DEPARTMENT OF TRANSPORTATION

Contract #: 04-0120F4Cty: SF/ALA Rte: 80 PM: 13.2/13.9File #: 1.28**WELDING INSPECTION REPORT****Resident Engineer:** Casey, William**Address:** 333 Burma Road**City:** Oakland, CA 94607**Report No:** WIR-027636**Date Inspected:** 19-May-2012**Project Name:** SAS Superstructure**OSM Arrival Time:** 700**Prime Contractor:** American Bridge/Fluor Enterprises, a JV**OSM Departure Time:** 900**Contractor:** American Bridge/Fluor Enterprises, a JV**Location:** Jobsite

Bridge No: 34-0006**Component:** SAS Components**Summary of Items Observed:**

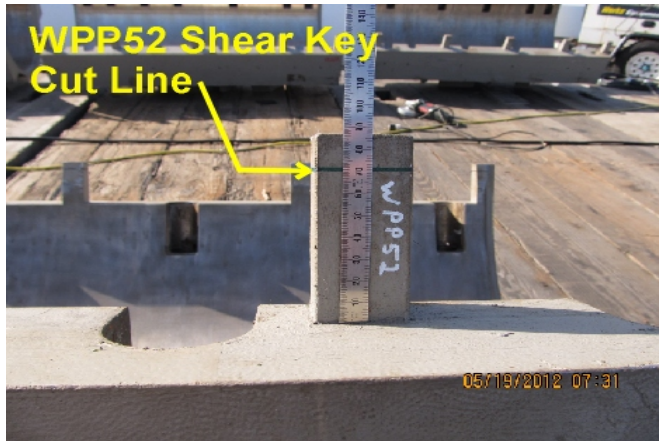
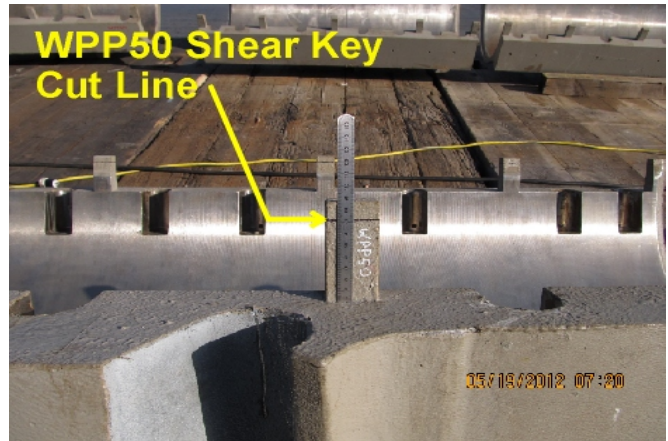
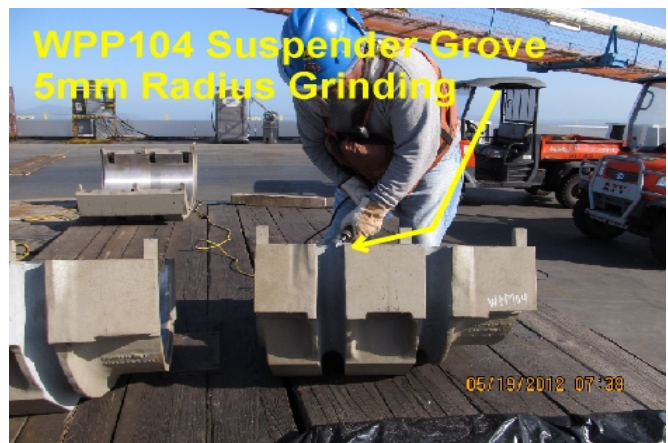
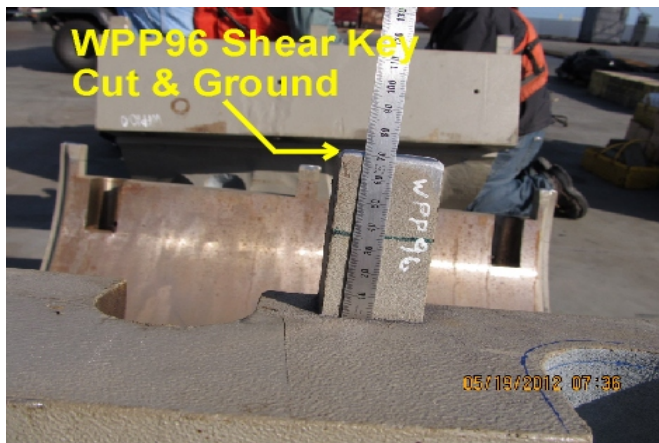
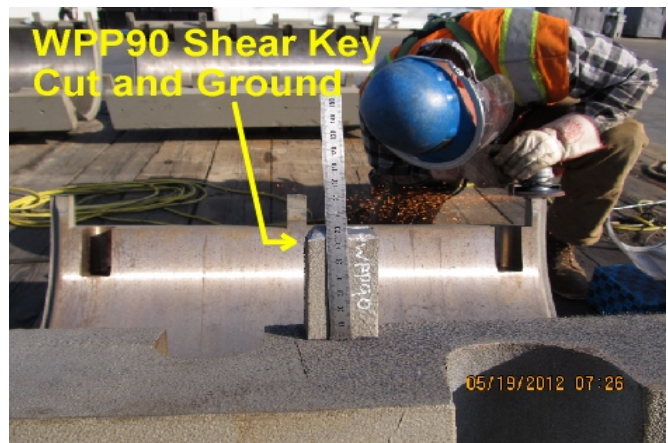
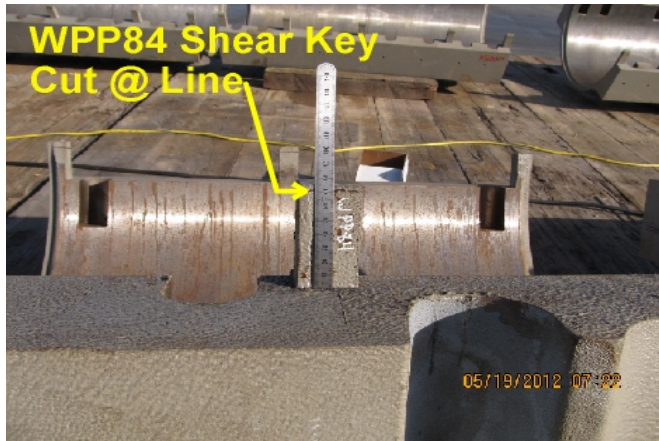
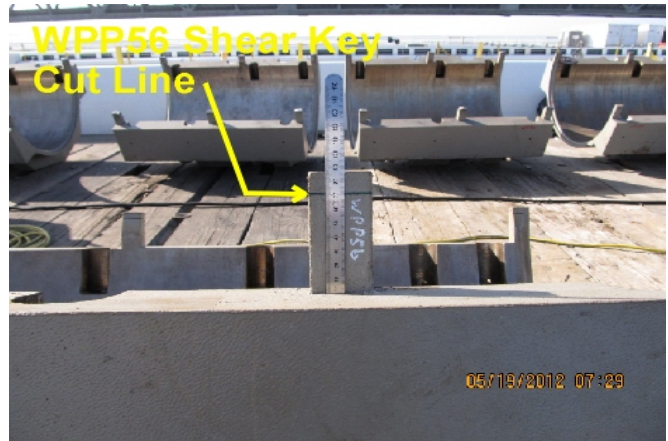
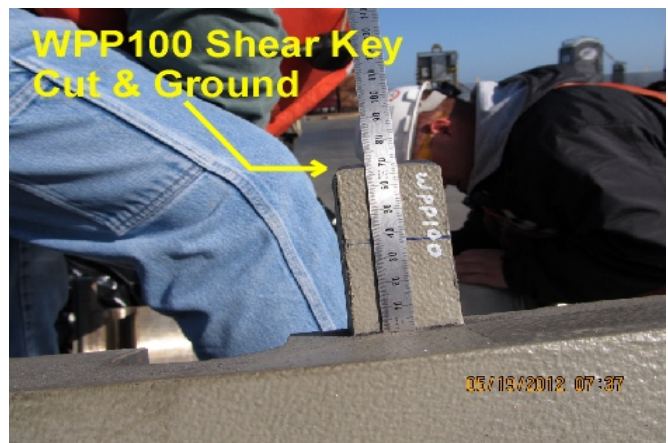
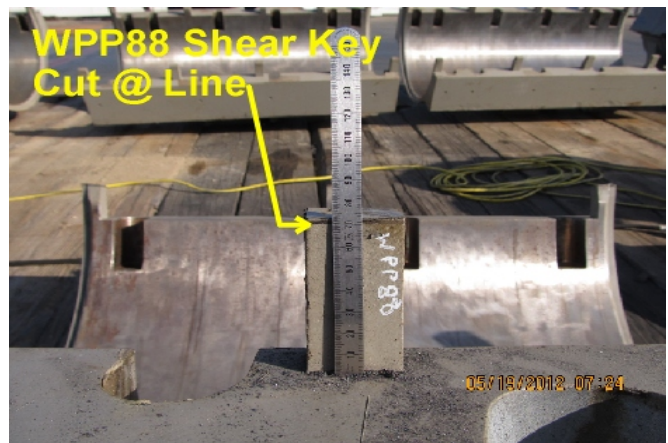
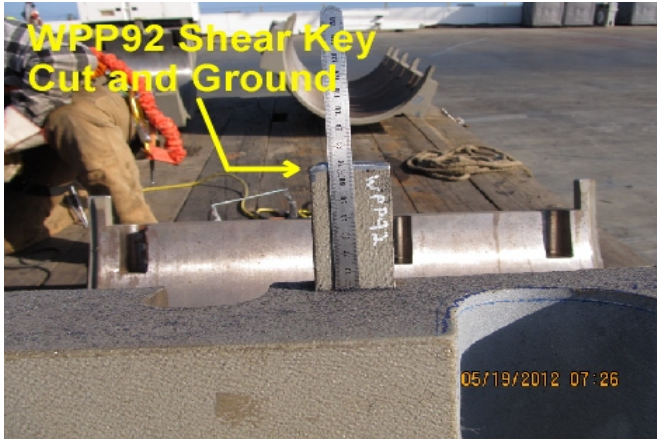
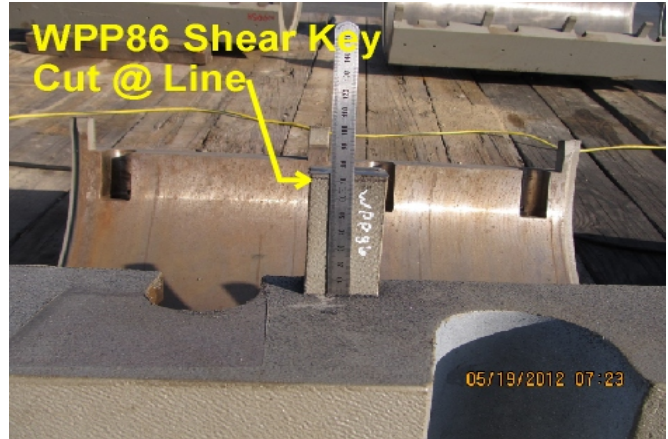
The QAI observed work in progress where the male Cable Band half shear key ends were in process of having 15mms removed by a power grinder with a cut off wheel and the cut edges dressed by a power grinder with a flapper disc as noted on "Red Line" changes to Goodwin Steel Castings Drawing No. 554Q-B2-1-M. The QAI noted that shear key detail "JOINT AT KEY", from Sheet labeled "CABLE BAND DETAILS NO. 3" denotes a chamfer face of 50mm, the removal of the key ends reduce that dimension by 15 + mm. The QAI did not have a RFI or Contract Change Order on hand for verification of workmanship above. The QAI was assigned off-site work by QAI supervisor William Levell and left before the end of shift. Work appears to be in general accordance with referenced documents above.
